Subject: F33615-90-4014, Order 04,
O&M Effort for the Bioventing System at the 7th Street BX Service Station
(May through August 1992), Eglin, AFB

This letter presents the results of the monitoring effort for the Bioventing System at the 7th Street BX Service Station. A summary of operation and maintenance efforts performed since system startup through August 21 is also included.

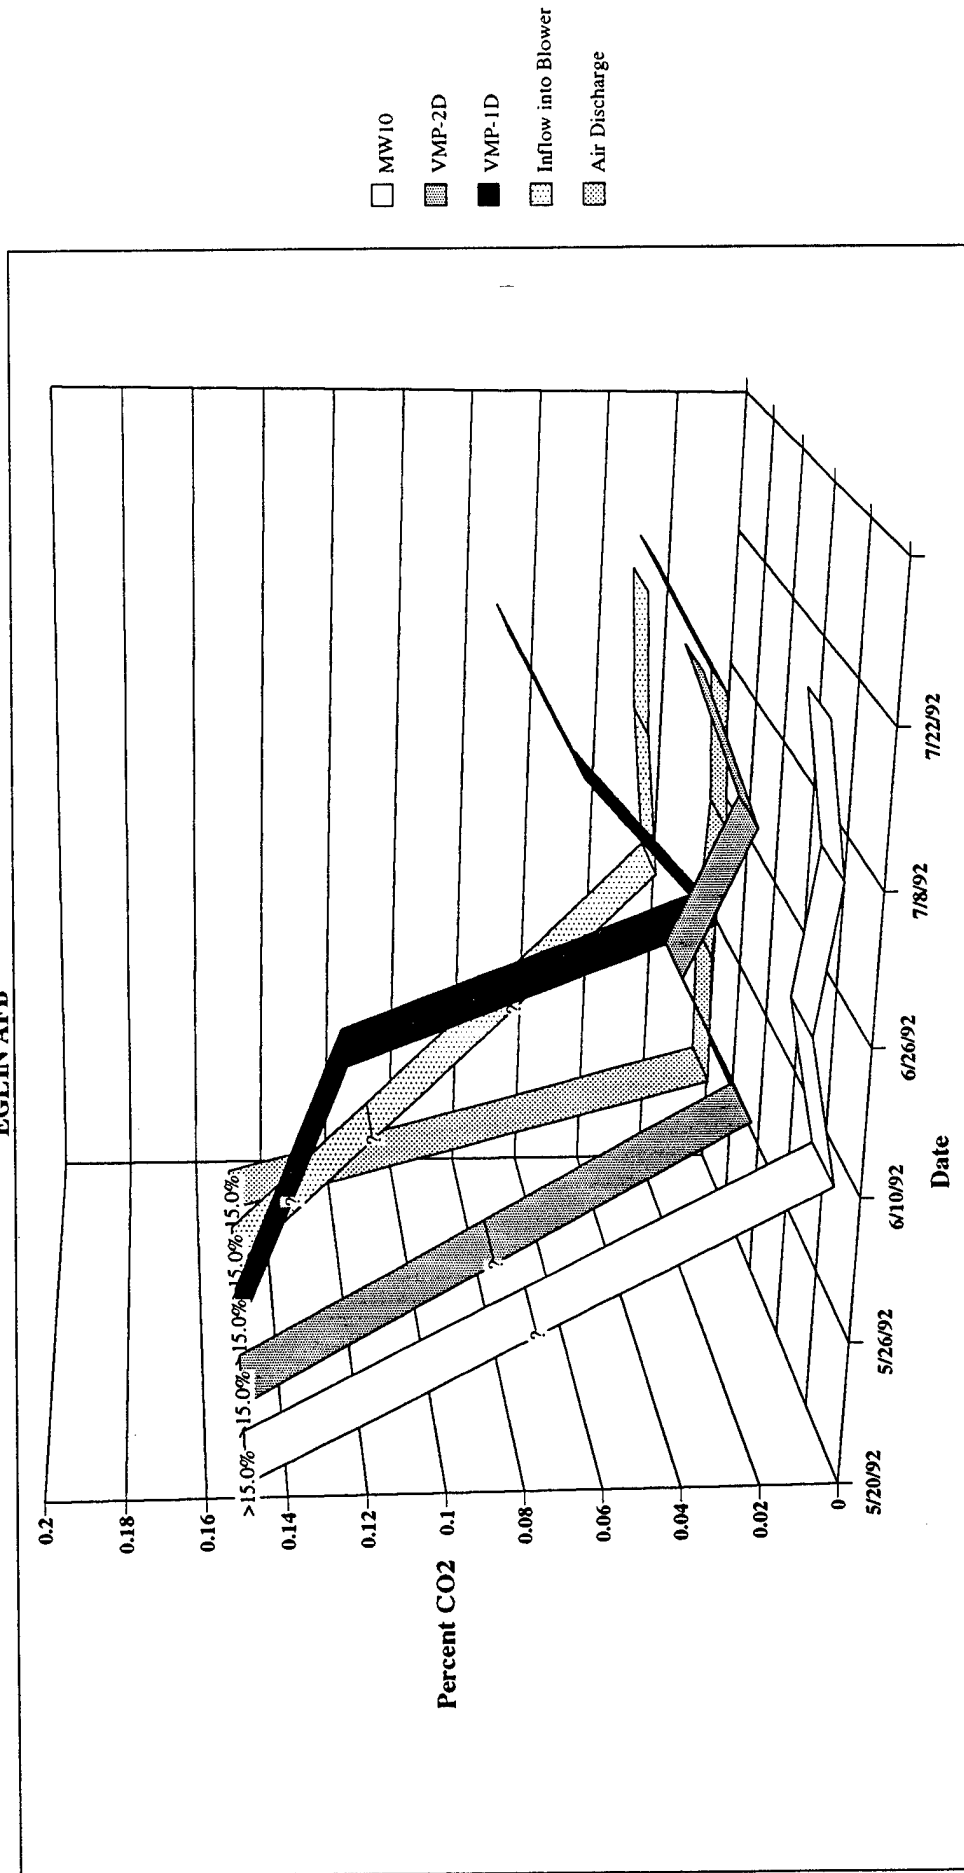
**CARBON DIOXIDE LEVELS DURING BIOVENTING
AT 7TH STREET BX SERVICE STATION (5/20/92 - 7/8/92)
EGLIN AFB**

Note: "?" indicates no data was recorded on this date; slopes are assumed to be linear.

Results of biweekly/monthly check of oxygen, carbon dioxide and Total Hydrocarbons in the off gas from the bioventing system are presented in Table 1. These results continued to indicate increased biological activity in the subsurface and suggest potential increase in aerobic bacterial population. Specifically oxygen supply to the subsurface has been adequately sustained. Notably, pre-venting condition indicated soil oxygen concentration of zero at VMP-1 and VMP-2. By July 22, oxygen concentrations at all monitoring locations have increased to values ranging from 9.8 to 20.0 percent. In contrast, carbon dioxide which was in excess of 15 percent prior to startup has declined to values ranging from 1.4 to 8.1 percent at all monitoring points.

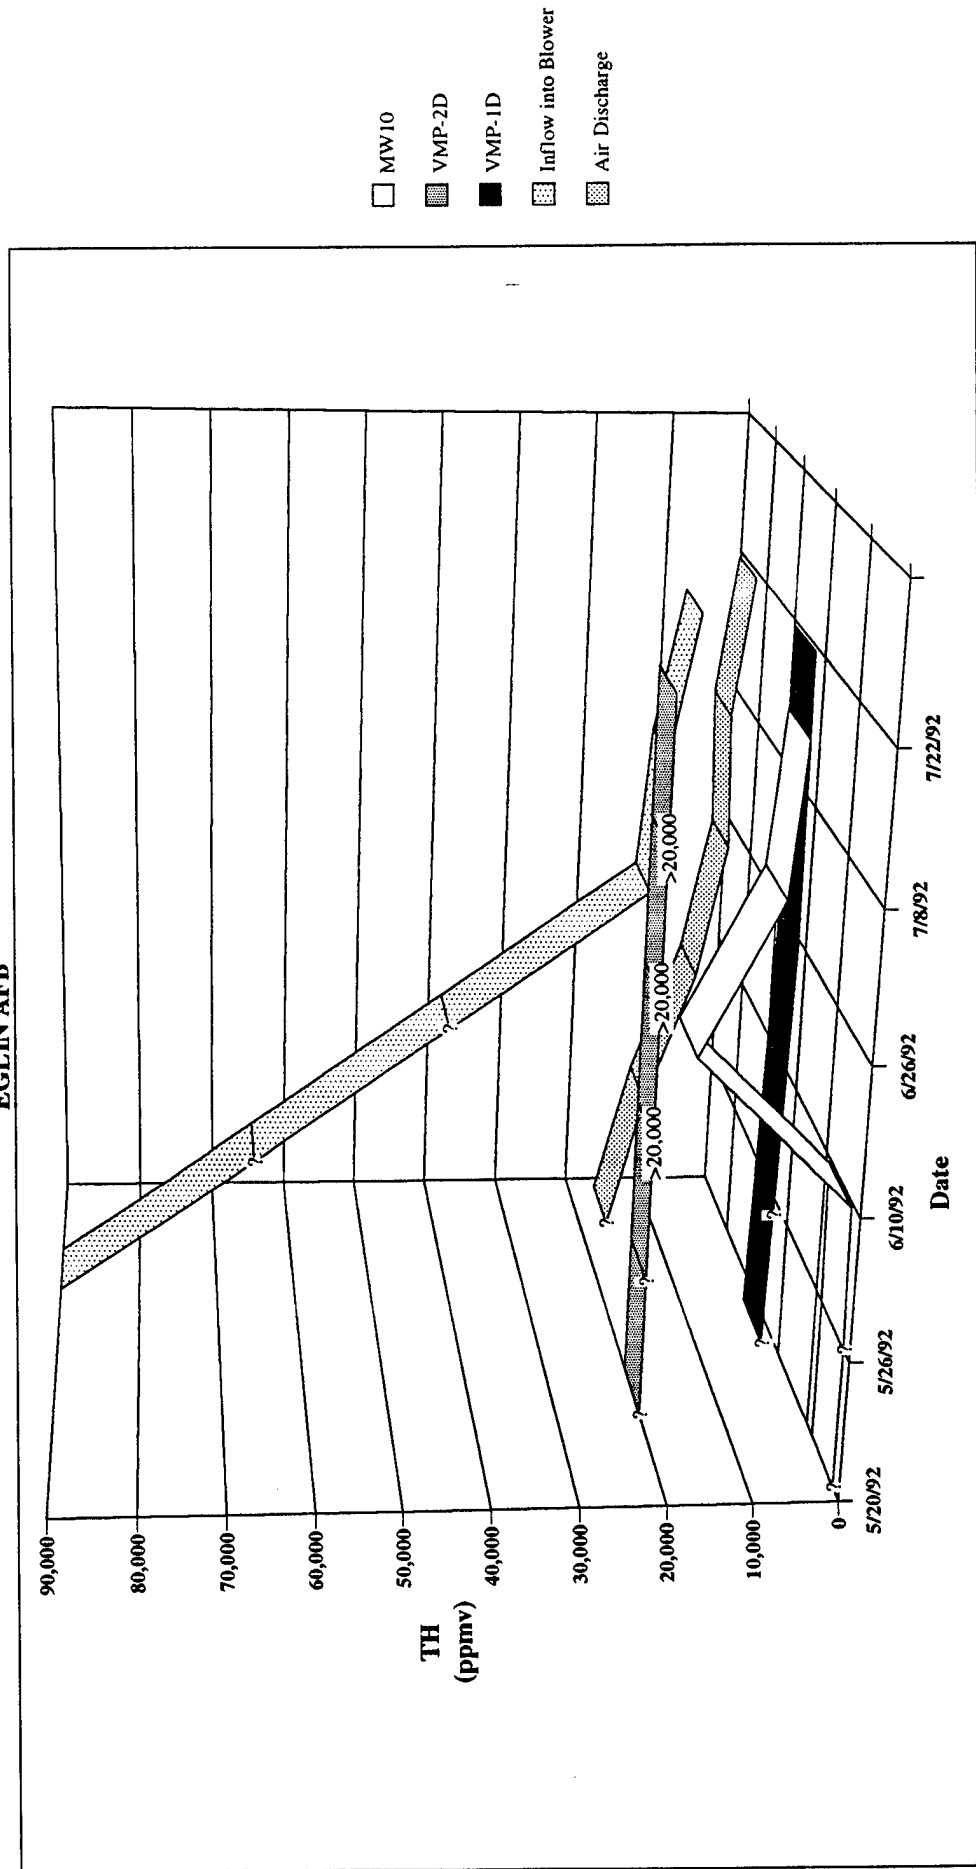
**TOTAL HYDROCARBON LEVELS DURING BIOVENTING
AT 7TH STREET BX SERVICE STATION (5/20/92 - 7/8/92)
EGLIN AFB**

Note: "?" indicates no data was recorded on this date; slopes are assumed to be linear.
